# Precast Block Houses Built in the 1950s and Urban Mining Potential

Urban mining, Industrialized housing, Precast concrete, Reuse, Russia

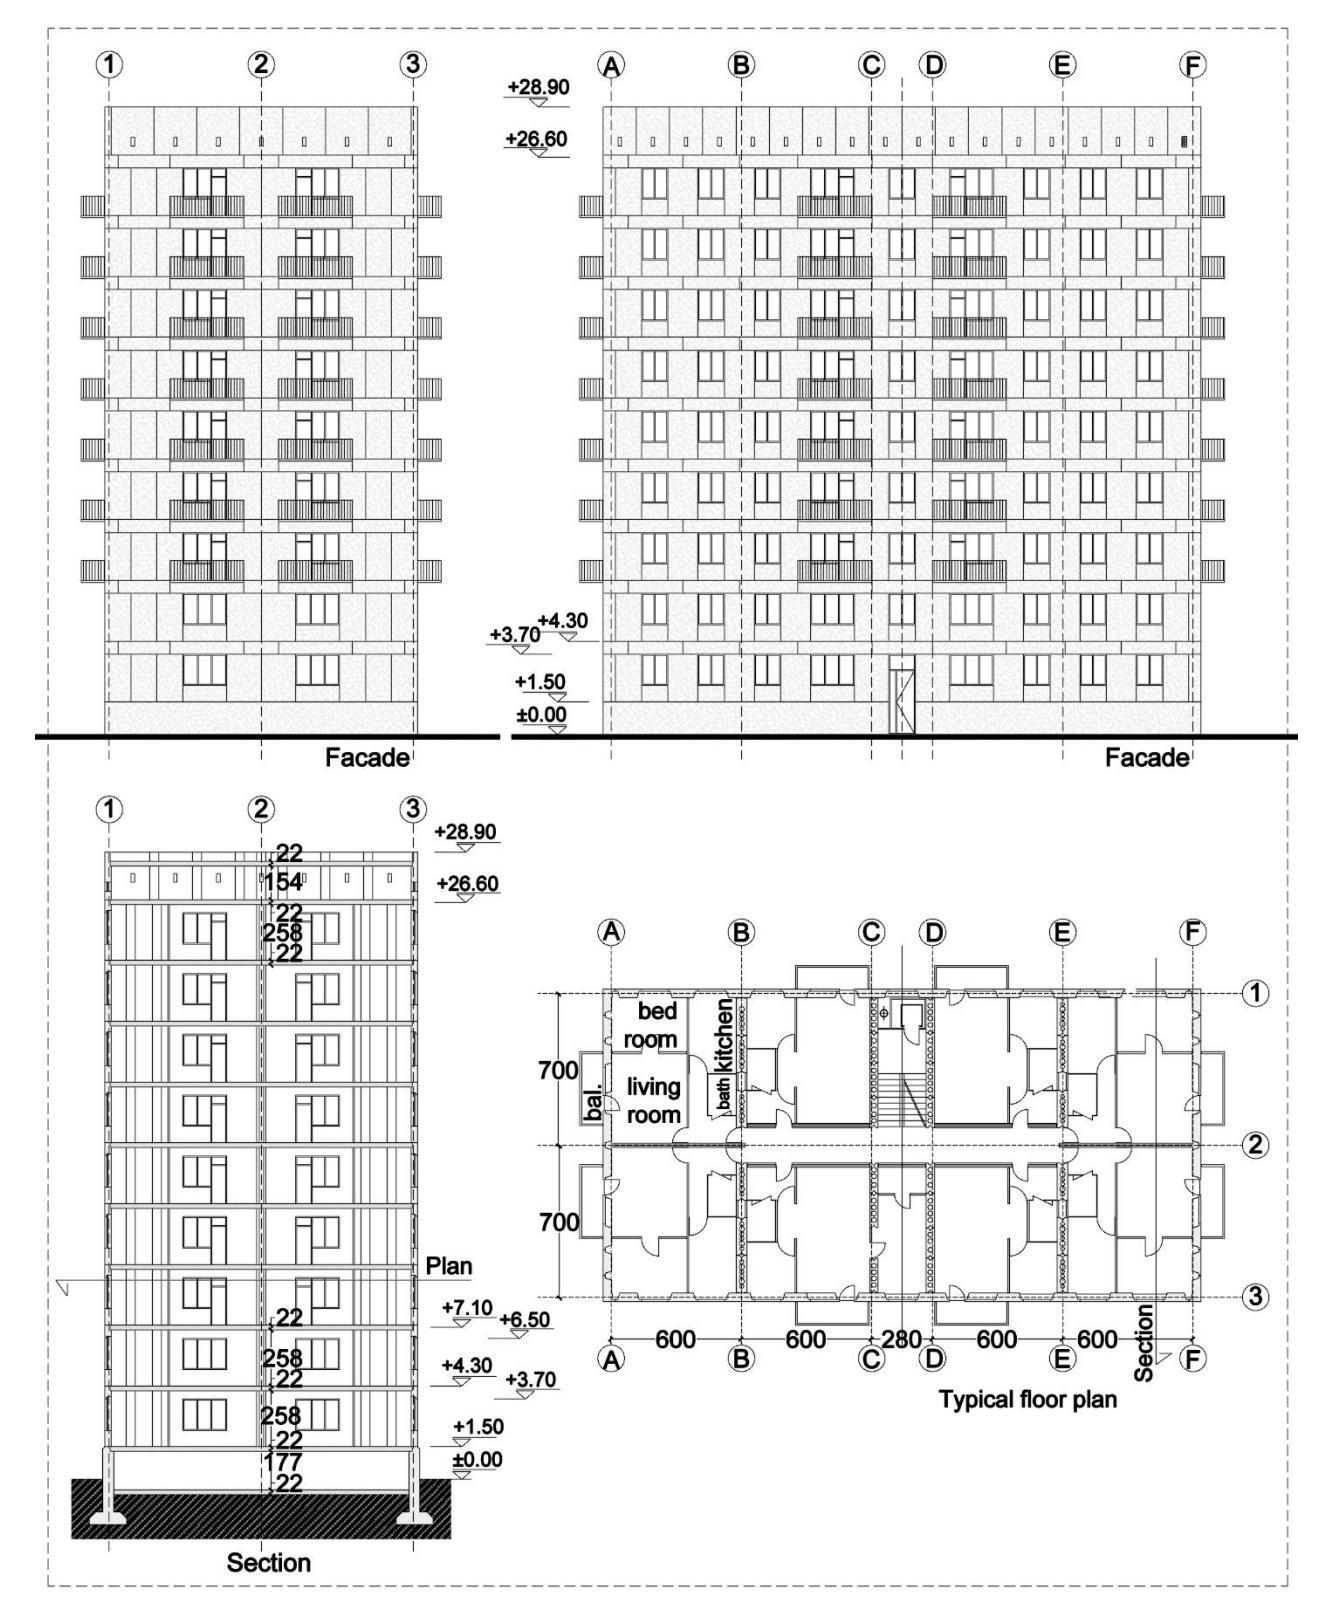
#### Figure 1 Design drawings (Adapted from Reference 15)

In addition to the nine floors with private apartments, a shared basement and an attic were present in the buildings. Eight symmetrically placed flats on each floor contained one or two rooms equipped with a tiny kitchen and bathroom, as shown in Figure 1. The buildings had a single circulation core, including the staircase, elevator, and trash chute. Each component of the buildings was a precast element -i.e., foundation unit, wall block, bond-beam, lintel, slab panel, and staircase [15 and 18].

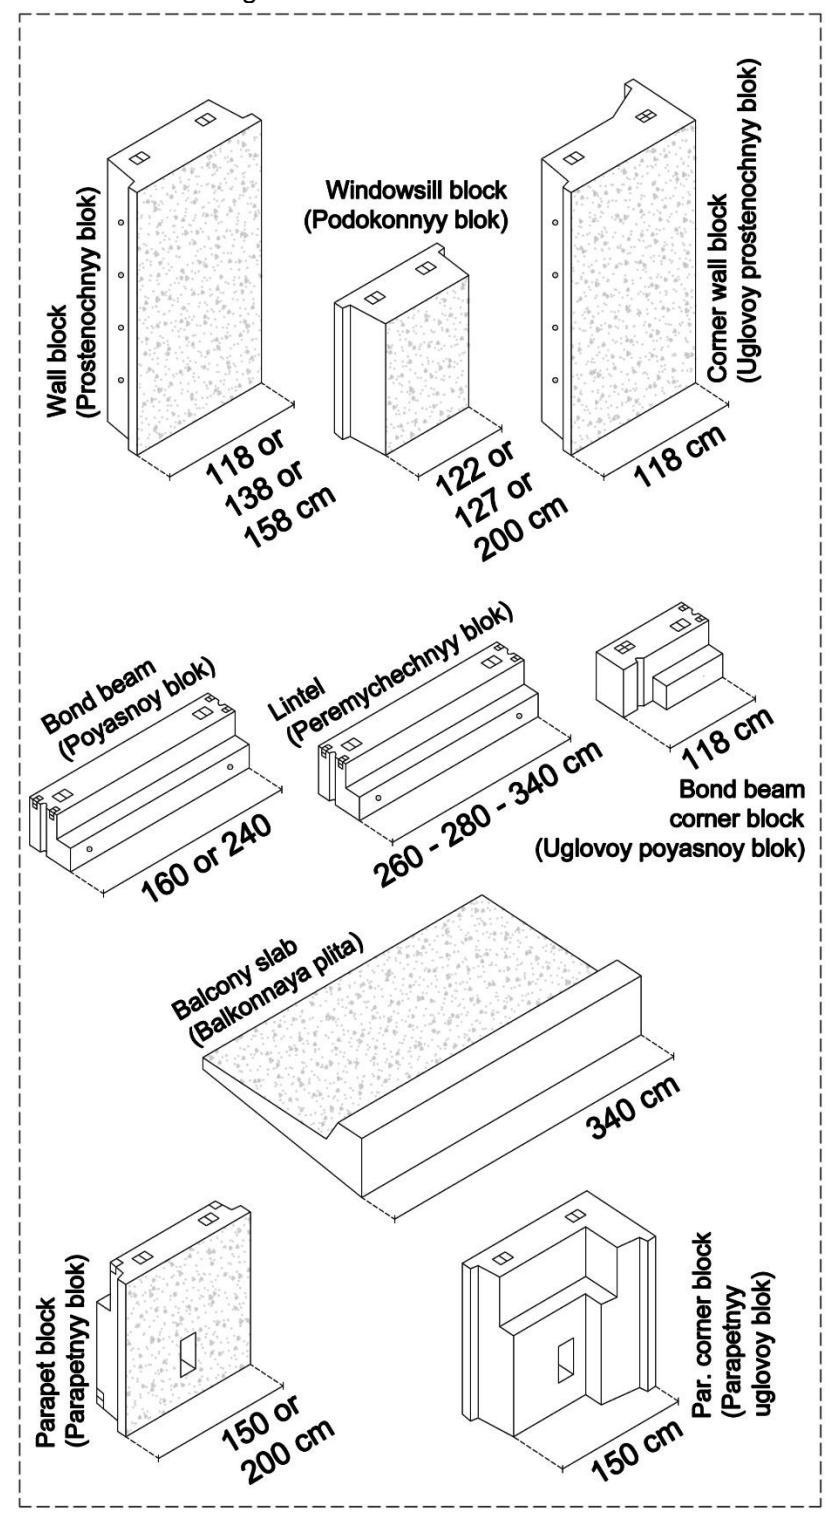
Figure 2 Facade components (Adapted from Reference 15, 19 and 21)

Wall blocks were 218 cm high with three alternative lengths -i.e., 118, 138, and 158 cm, as shown in Figure 2. Reinforcement bars in these blocks were near the head joints for their integration during the construction. Four holes on the edges allowed constructors to unite the bars of side-by-side blocks.

Moreover, extended bars on top of the blocks formed steel hangers to elevate these heavy components using a crane. Specific blocks with L-shape-plan formed the corners of the buildings. 32-cm-thick and 76-cm-high sill blocks had the mortises on their inner surfaces, unlike walls. Bond-beams and lintels were identical L-section-components, while the former connected the walls of consecutive floors with the slab panels; the latter was on the fenestration openings, as shown in Detail 5, Figure 3. The critical difference between these 58-cm-high and 40-cm-thick elements was the density of reinforcement. Lintels comparatively contained more steel bars placed at three levels, upper, middle, lower, and secured by densely located stirrups. Bond-beams, including specific corner ones, and lintels surrounded the perimeter of the building on each floor for stiffness.

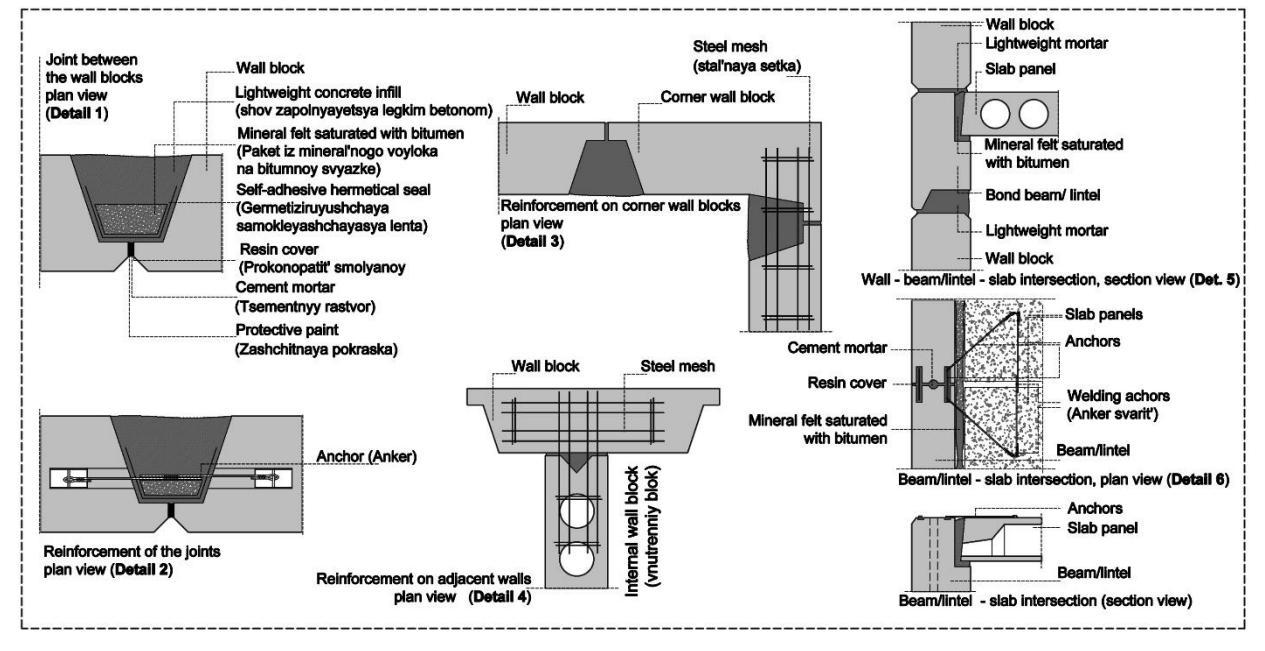
#### Figure 3 Connection details (Adapted from Reference 15, 19-21)

The initial installation took place between the reinforcements of adjacent wall blocks using anchors through the mounting holes [15, 18, and 20]. Afterward, cement grout filled the joint and integrated all together, as shown in Detail 1 and 2 (Figure 3). Following the installation of walls, their topsides were mortared with lightweight concrete to integrate bond-beams and lintels. The mixture was plain except the corners of the building and where outer and inner load-bearing walls were adjacent. Meshes embedded in mortar confined these intersections, as shown in Detail 3 and 4. Unlike wall blocks, bond-beams and lintels contained embedded grooves for the placement of anchors and grout, as seen in Detail 6 (Fig. 3). Anchors and mortar connected the adjacent slab panels and the beams, as shown in Detail 5 and 6.

Lastly, bitumen-saturated mineral felt and self-adhesive hermetical seal isolated the joints against water leaks. Additionally, dense mortar layer and resin constituted the outer surface of these intersections.

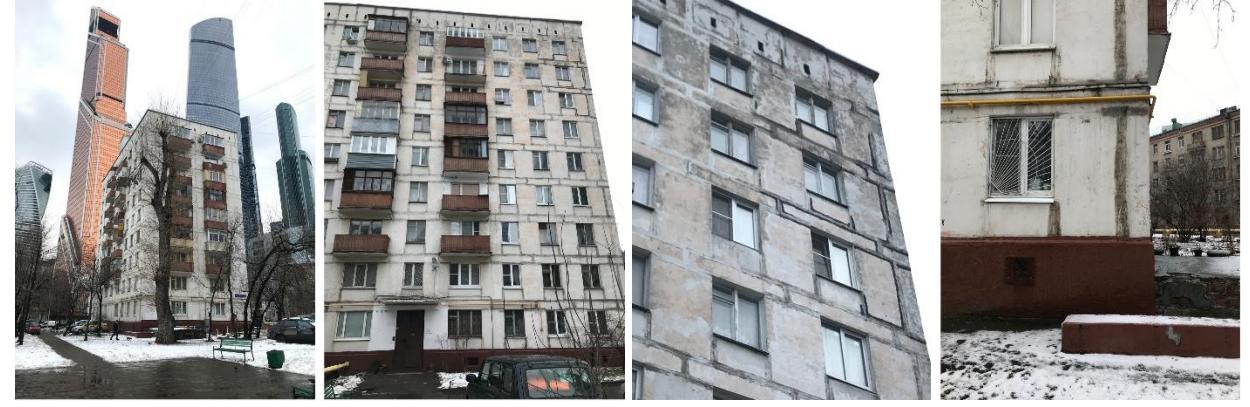
### Figure 4 Sample building #1

Ten randomly selected buildings generated the set of precast facade elements to survey. Building #1, located in *Krasnogvardeisky passage 18k2*, exhibited decay, improper repairs, and water leaks at the joints. Moreover, wall components had fine surface cracks and deterioration on paint, as shown in Figure 4. Sill blocks had a significant color change due to humidity, while balcony slabs had exposed and corroded steel bars. In an overall assessment, this building gained the average condition label. Consequently, all buildings fell into four categories according to their current condition; poor, average, good, and very good. One building was poor, five were average, two were good, and two were very good, as seen in Figure 5.

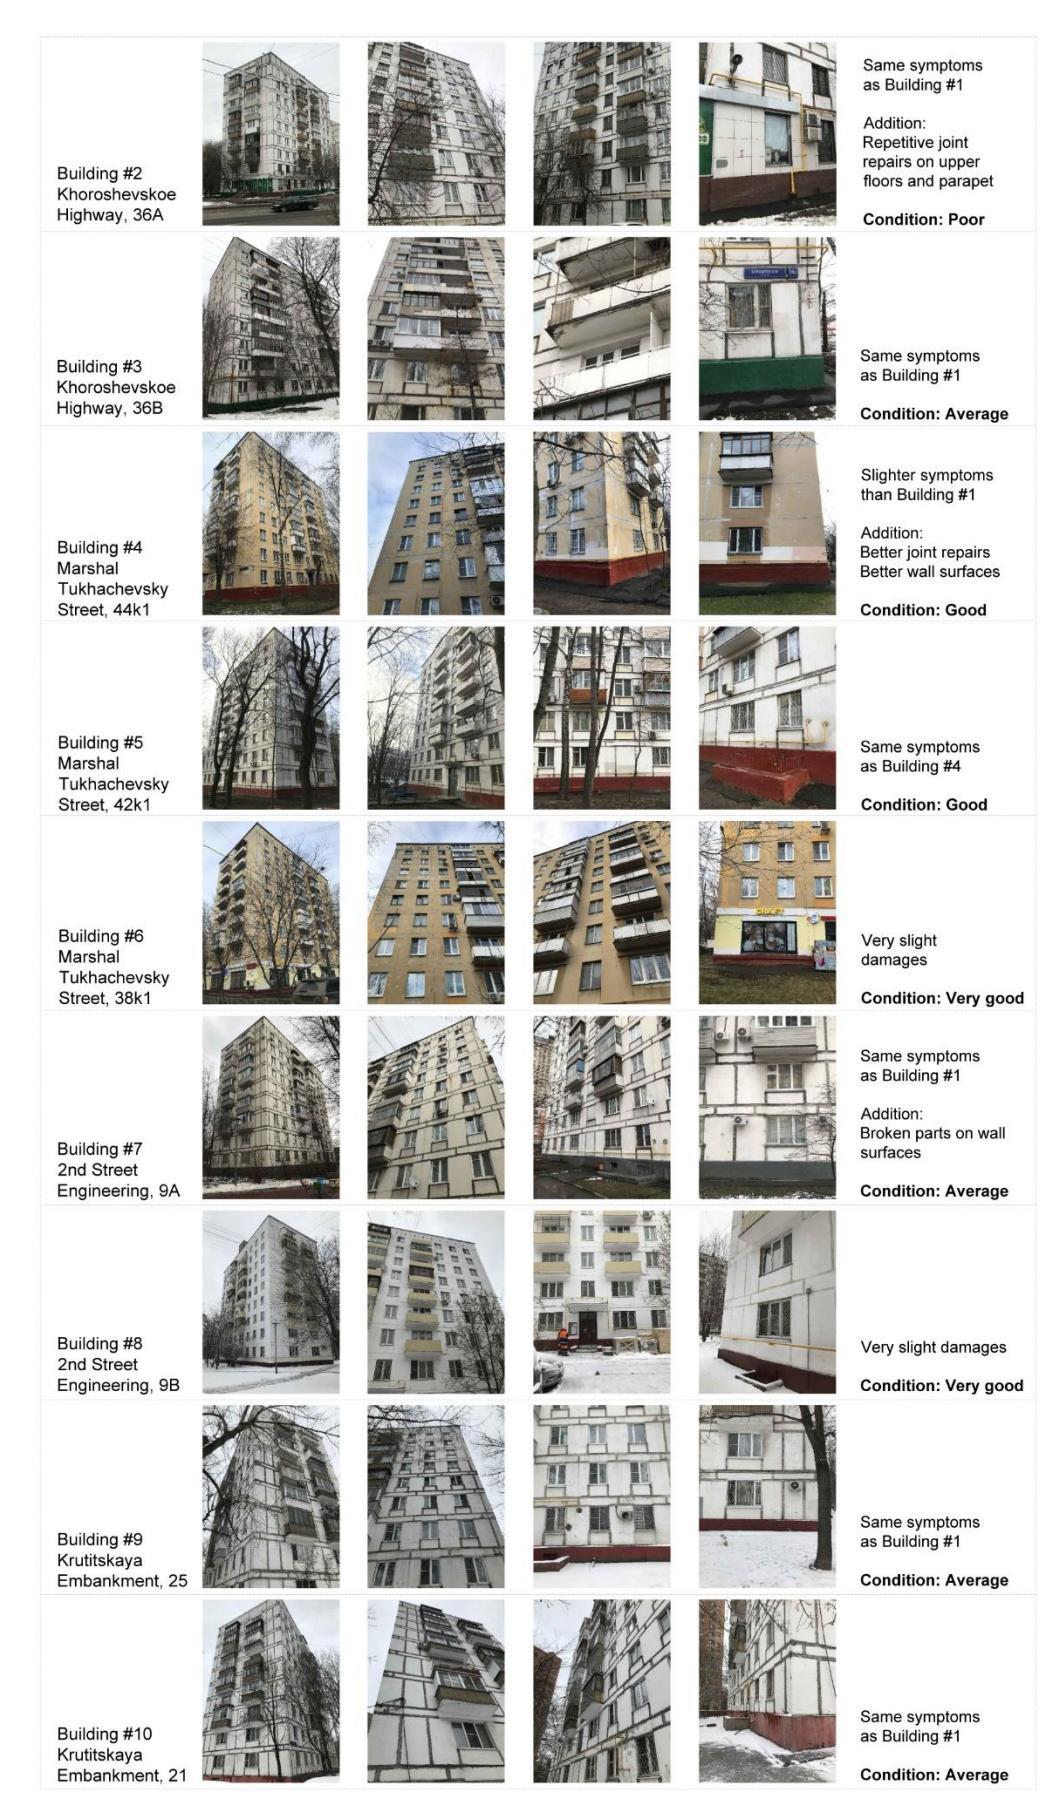
Figure 5 Sample buildings (See the appendix for larger images)

The primary issue of all structures was the deterioration of joints to some extent. Separation of adjacent blocks and the fillers remained a recurring problem not only between wall blocks but also between bond-beams and lintels, as seen in Building #1,5,7, and 9. This separation appeared in the form of 2-3-mm-thick cracks and surrounded by discoloration due to fungal activity triggered by the presence of humidity. The problem grew up in distinct points: upper floors, including parapets (Building #1 and 2) and sides of windowsills (Building #1,4, and 9). Freeze and thaw of rain and snow water, as well as inadequate water discharge, increased the rate of decay at these particular points. Although the principle design of connections had measures against water penetration, as shown in Detail 1-6 Figure 3, the implementation of solutions was either not adequate during construction or had to be repeated more frequently throughout the service life. Similarly, window and parapet-sills had slopes in the planning stage but were incapable of conveying the water away from the blocks in practice.

Decayed concrete balcony slabs represented the second common problem in the buildings, as was evident in Building #3. Steel bars reached out through the crumbled concrete and corroded below the cantilever edges of these slabs. According to the original design, there was not a water discharge system for these slabs, except for a slight slope; and it resulted in severe damage during the operation phase. This problem was not present for the enclosed balconies.

The surface quality of wall components was satisfactory even for the buildings in an unfavorable condition, as shown in Building #2. Scarce thin cracks seemed to stay only on the protective paint layer and did not grow in the components. This pleasing condition was likely due to the operational effectiveness of the 2-cm-thick dense protective coating. The only significant crack was on the corner of a bond-beam, as shown in the last photo of Building #10.

Among recovered components, windowsills and walls blocks next to them and parapets need further investigation for reinforcement corrosion. These were the zones where the steel bars were close, and the humidity was constant. Moreover, balcony slabs require repair for the same damage in case of their reuse.

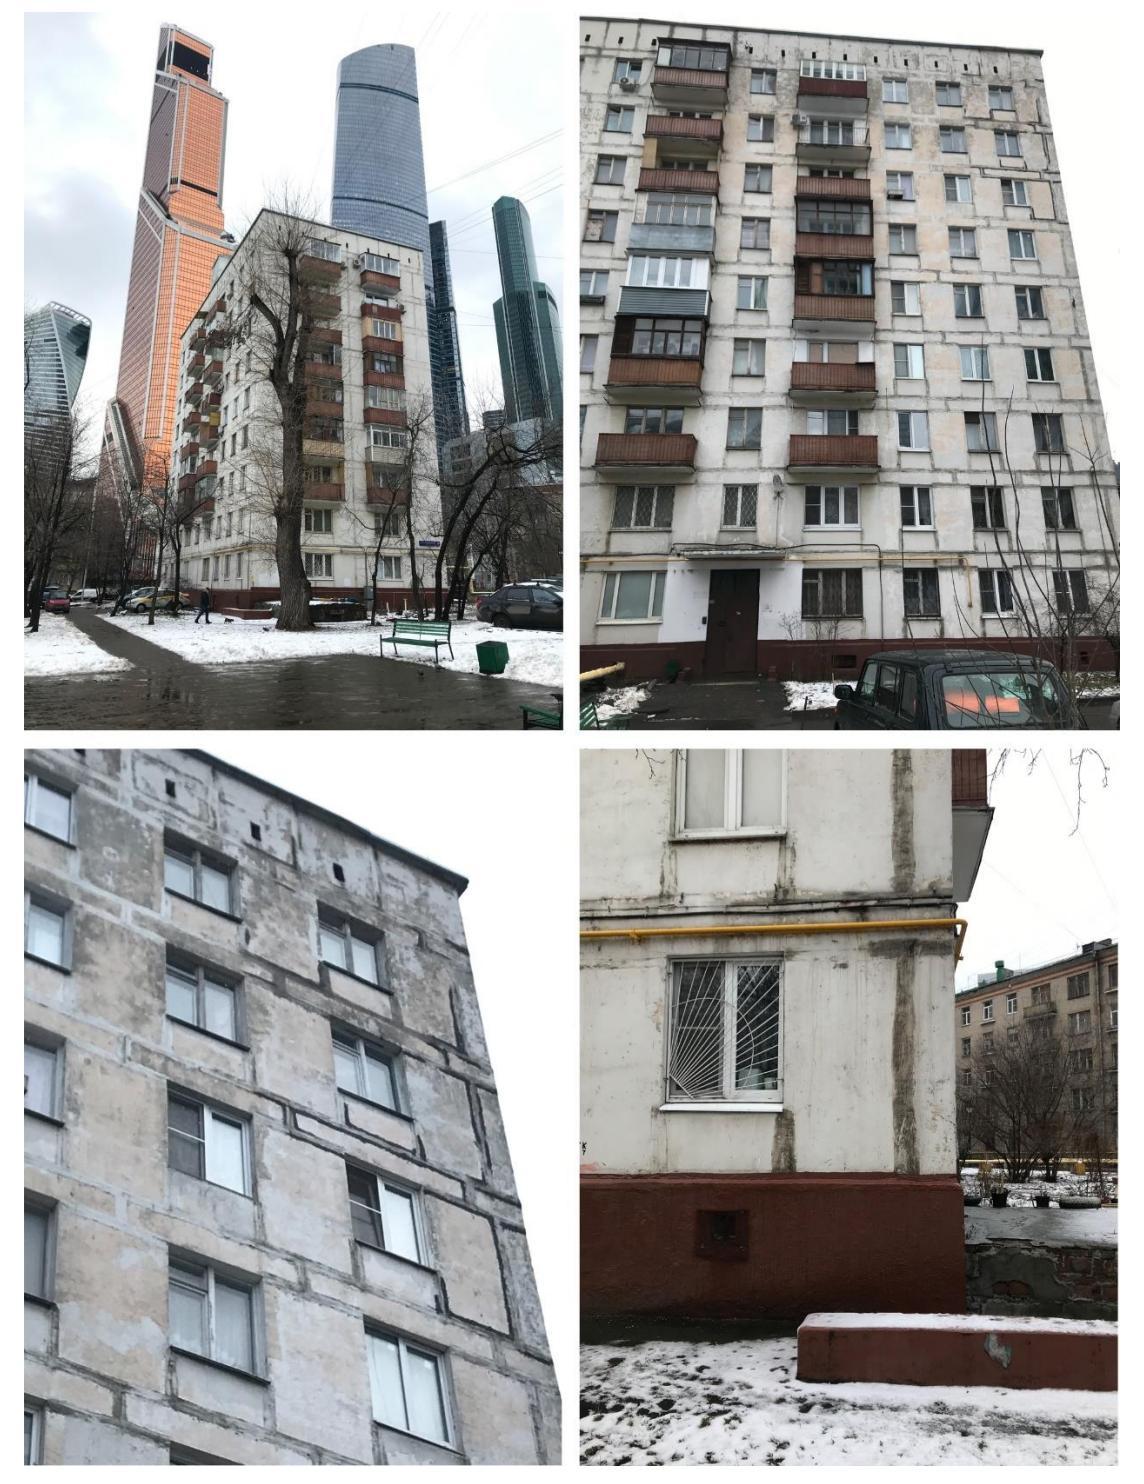
Figure A1 Building #1 Joints: Partial separations, improper repair, water problem, and decay. Blocks: Paint decay and fine surface cracks. Sill blocks: Water problem. Balcony slabs: Separation of clear cover and corrosion of reinforcement. Condition: Average

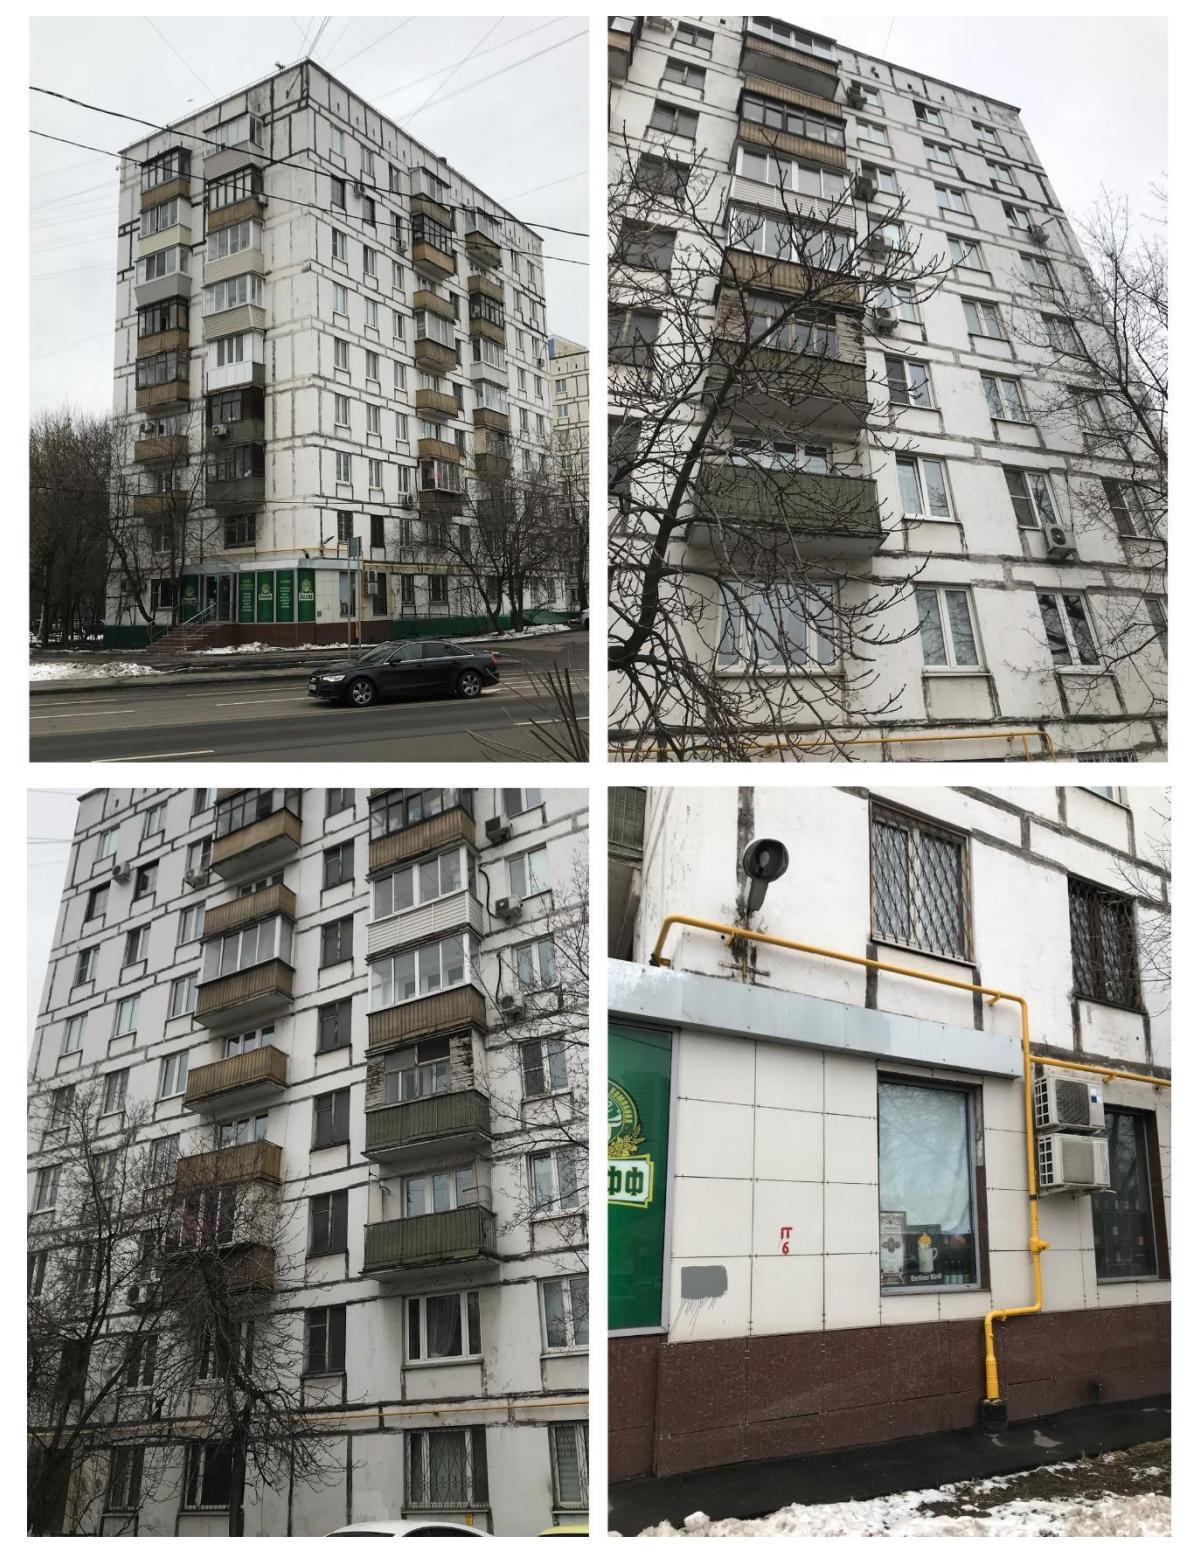
Figure A2 Building #2 The same symptoms as Building #1 Addition: Repetitive joint repairs on upper floors and parapet. Condition: Poor

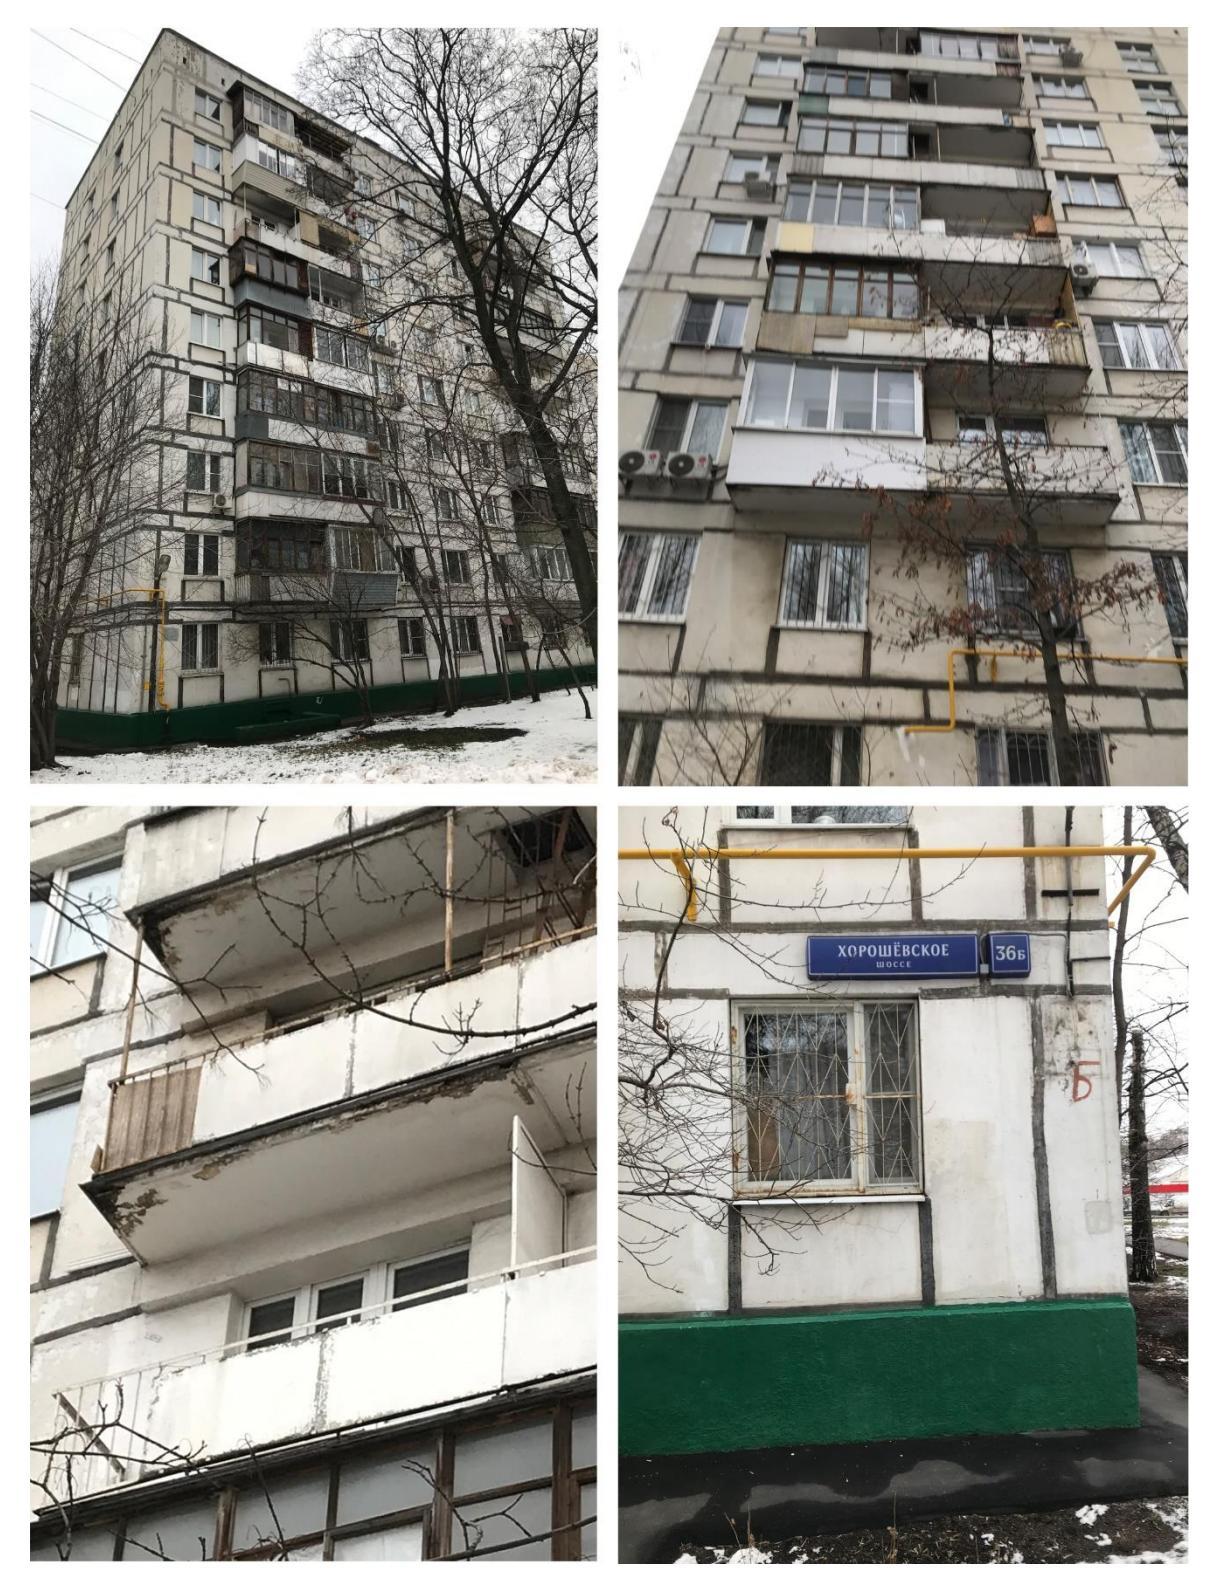
Figure A3 Building #3 The same symptoms as Building #1. Condition: Average

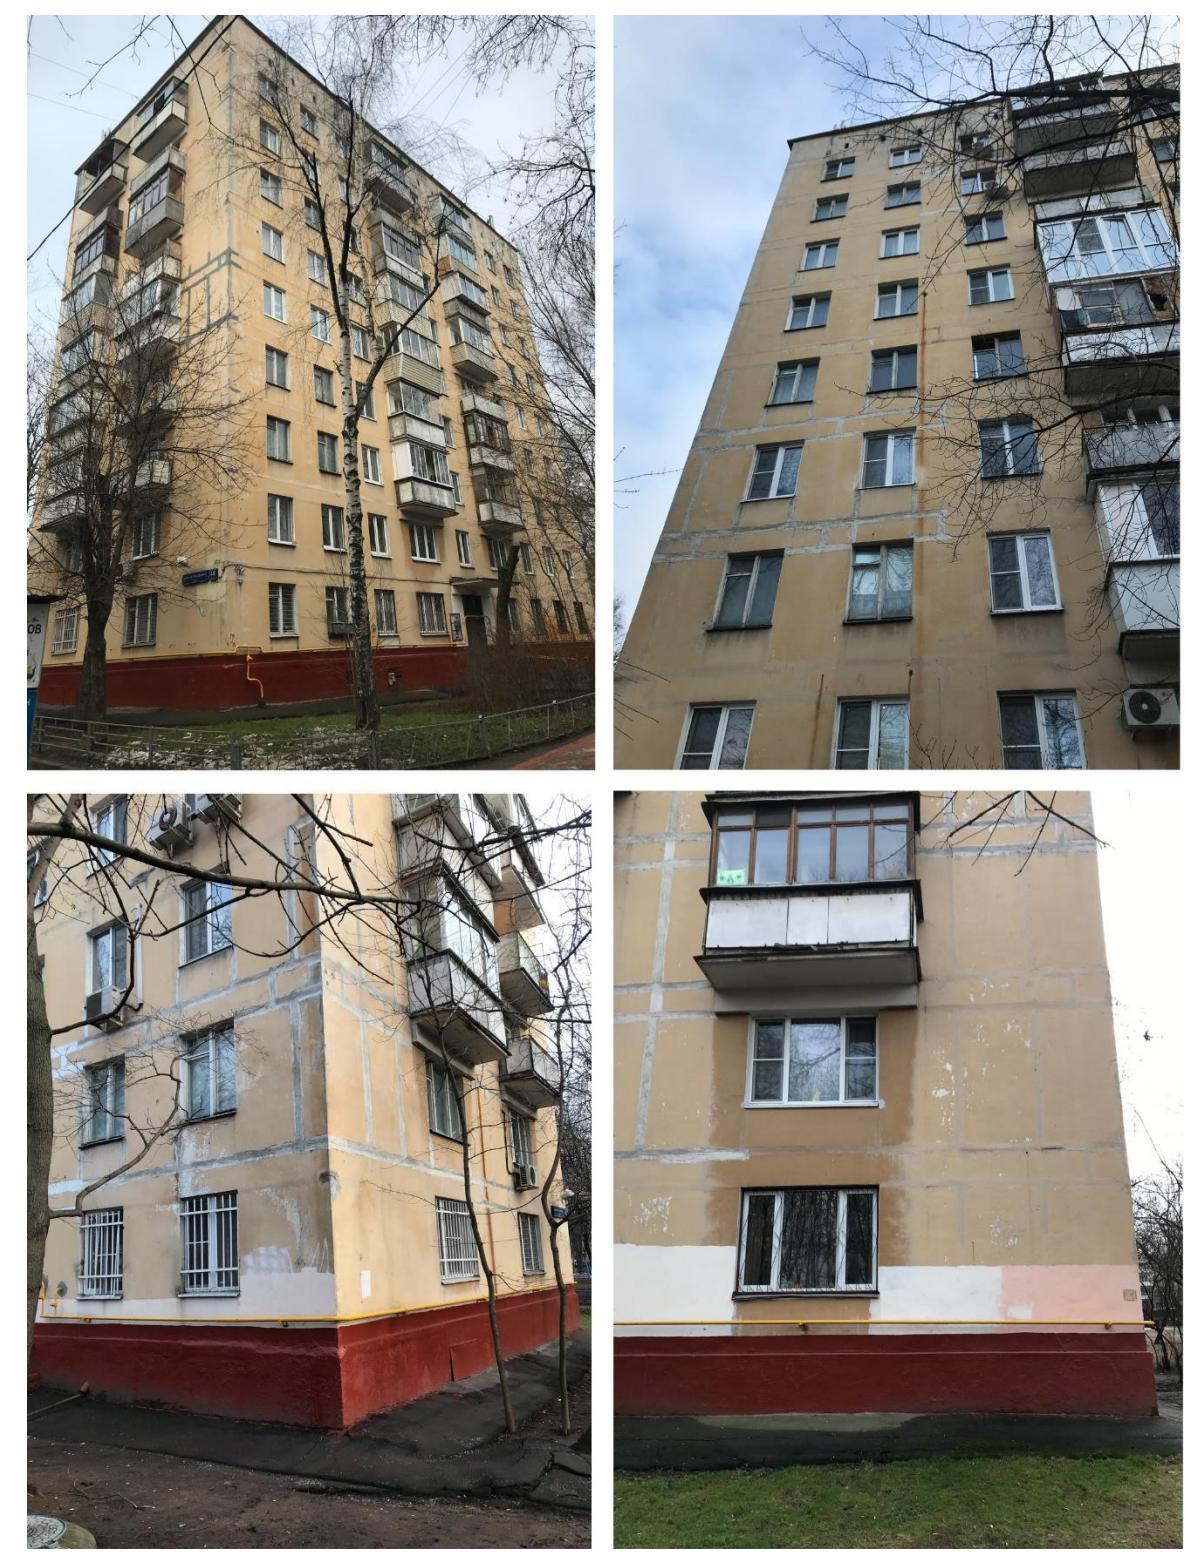
Figure A4 Building #4 Slighter symptoms than Building #1 Addition: Better joint repairs, Better wall surfaces. Condition: Good

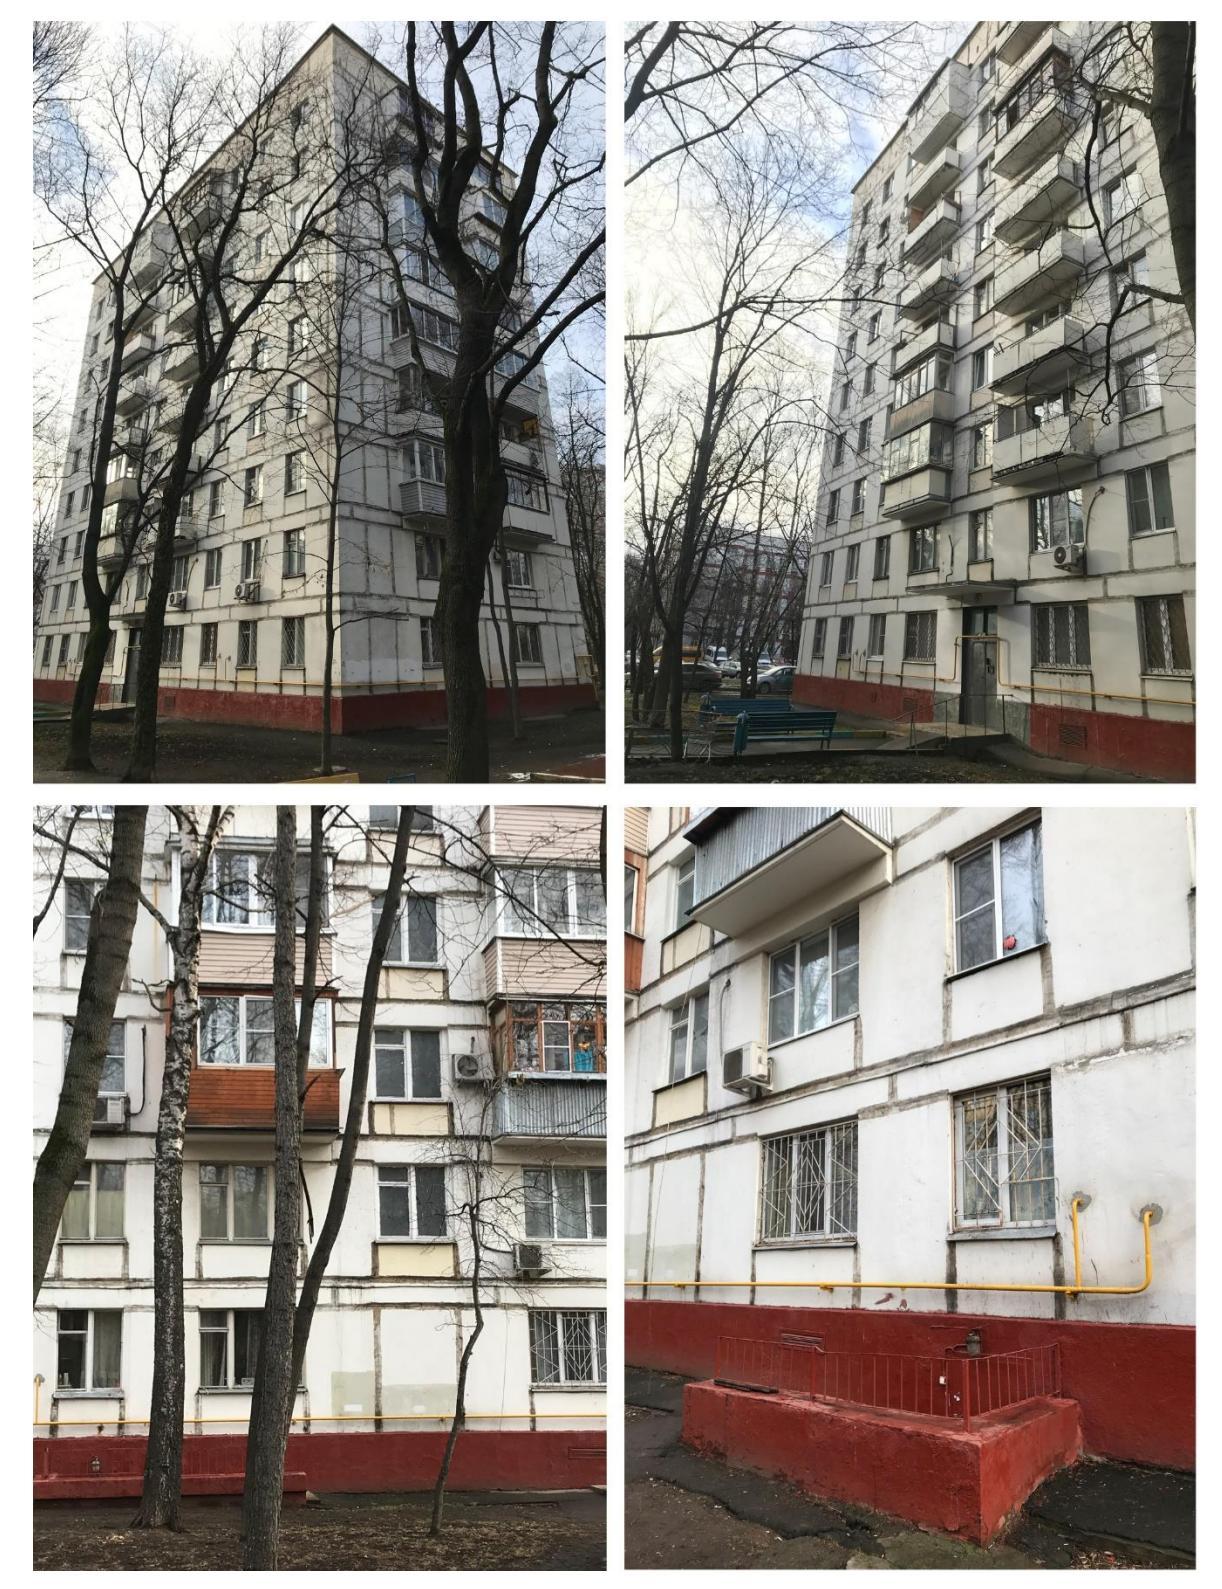
Figure A5 Building #5 The same symptoms as Building #4. Condition: Good

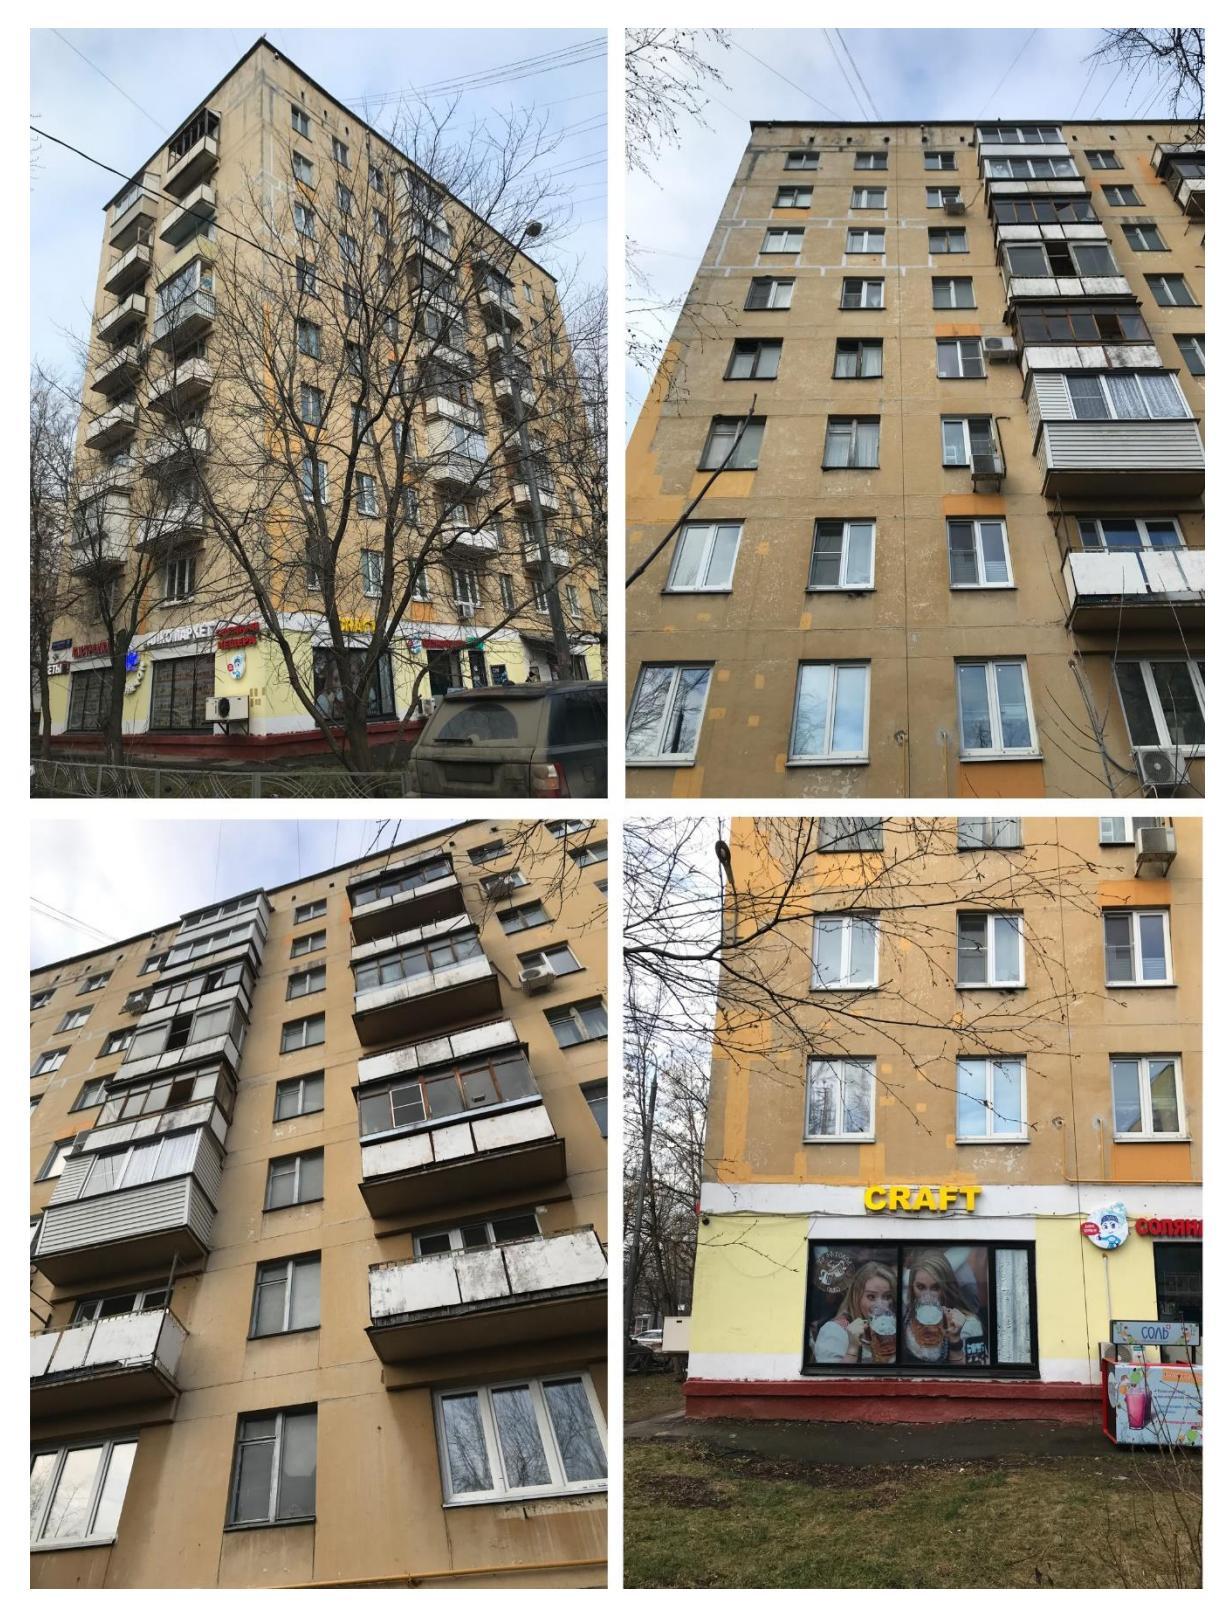
Figure A6 Building #6 Very slight damages. Condition: Very good

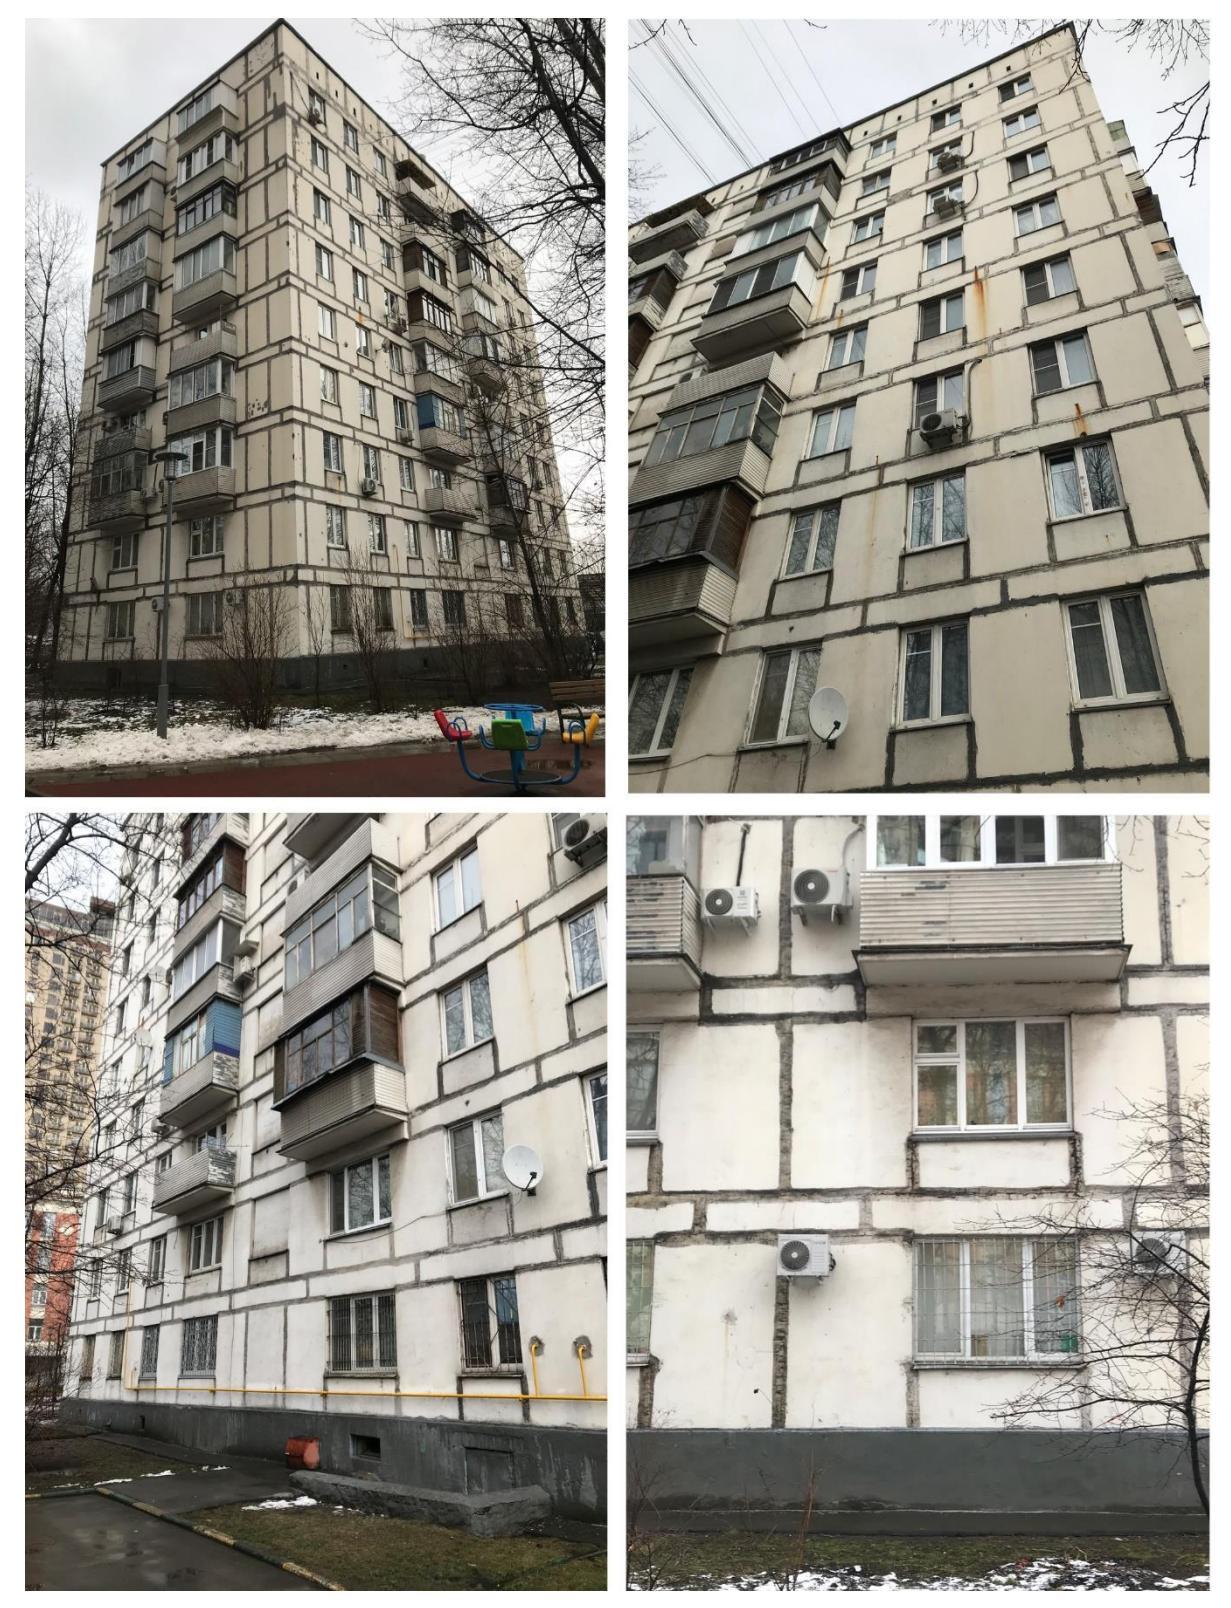
Figure A7 Building #7 The same symptoms as Building #1 Addition: Broken parts on wall surfaces. Condition: Average
