# Precast Block Houses Built in the 1950s and Urban Mining Potential

Urban mining, Industrialized housing, Precast concrete, Reuse, Russia

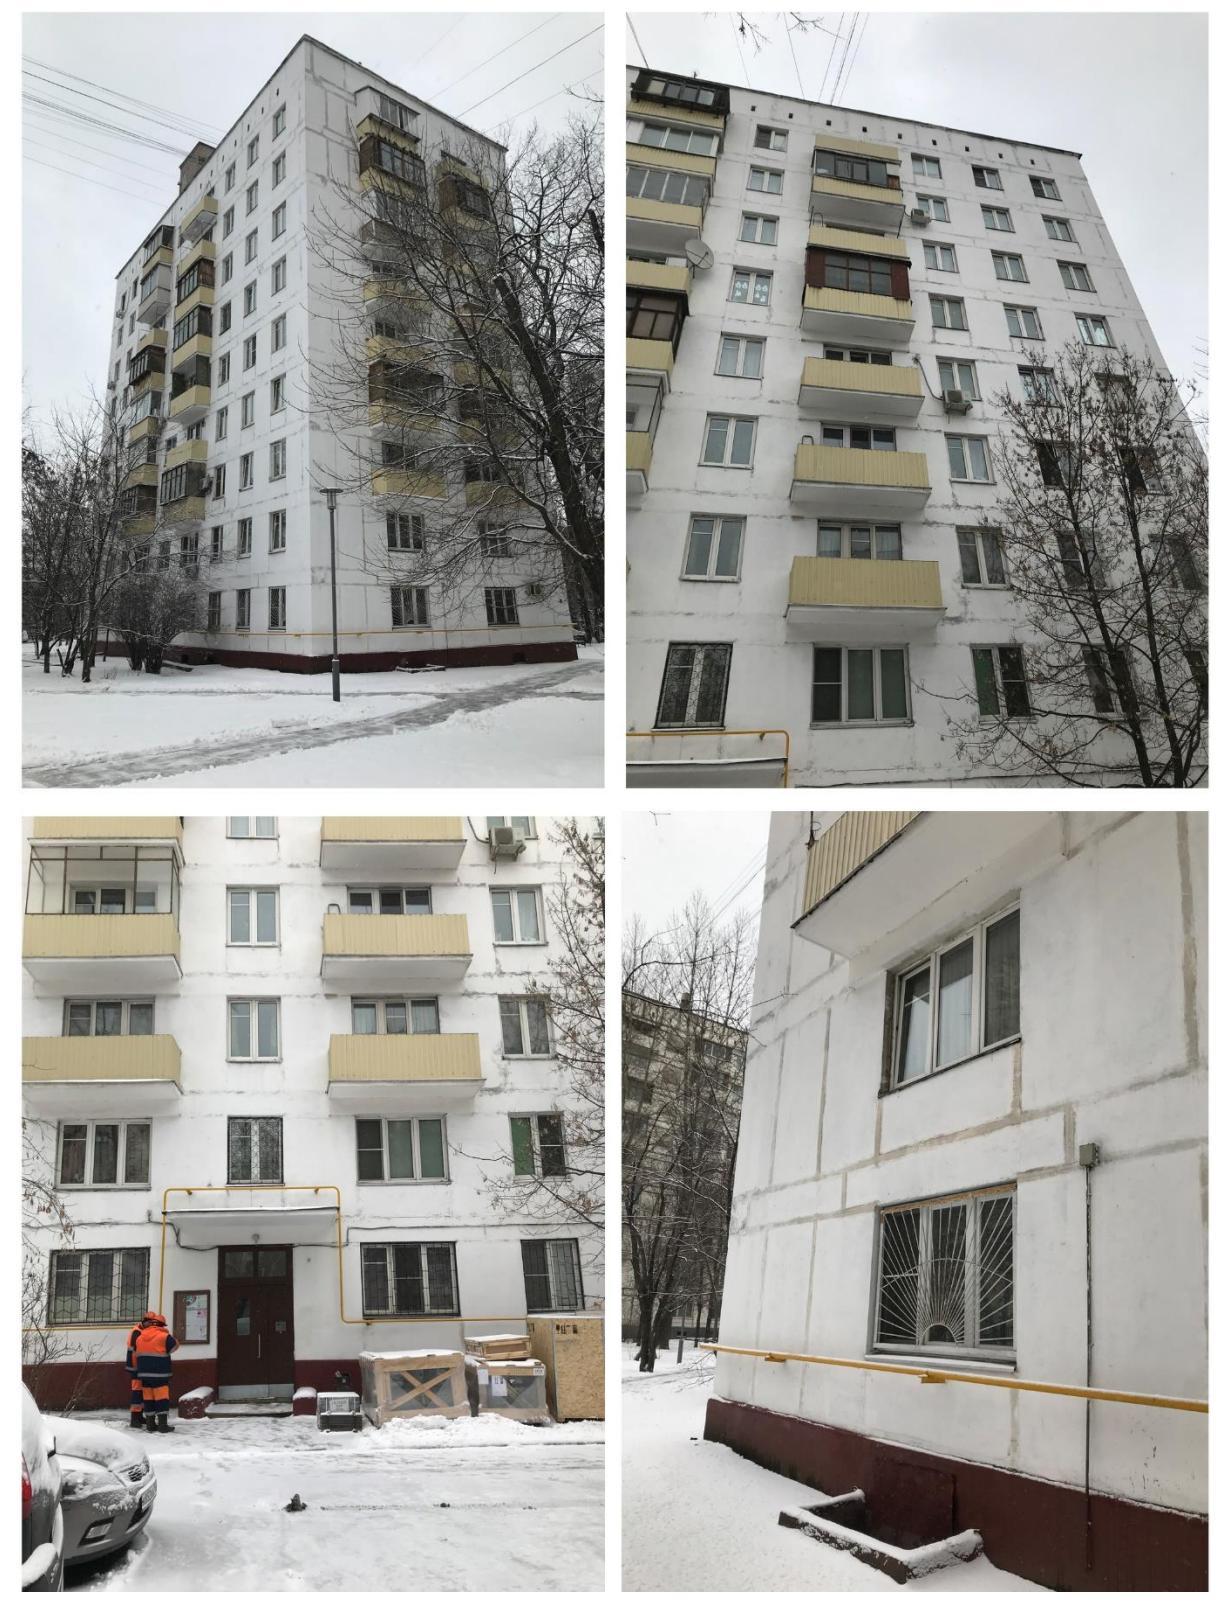
Figure A8 Building #8 Very slight damages. Condition: Very good

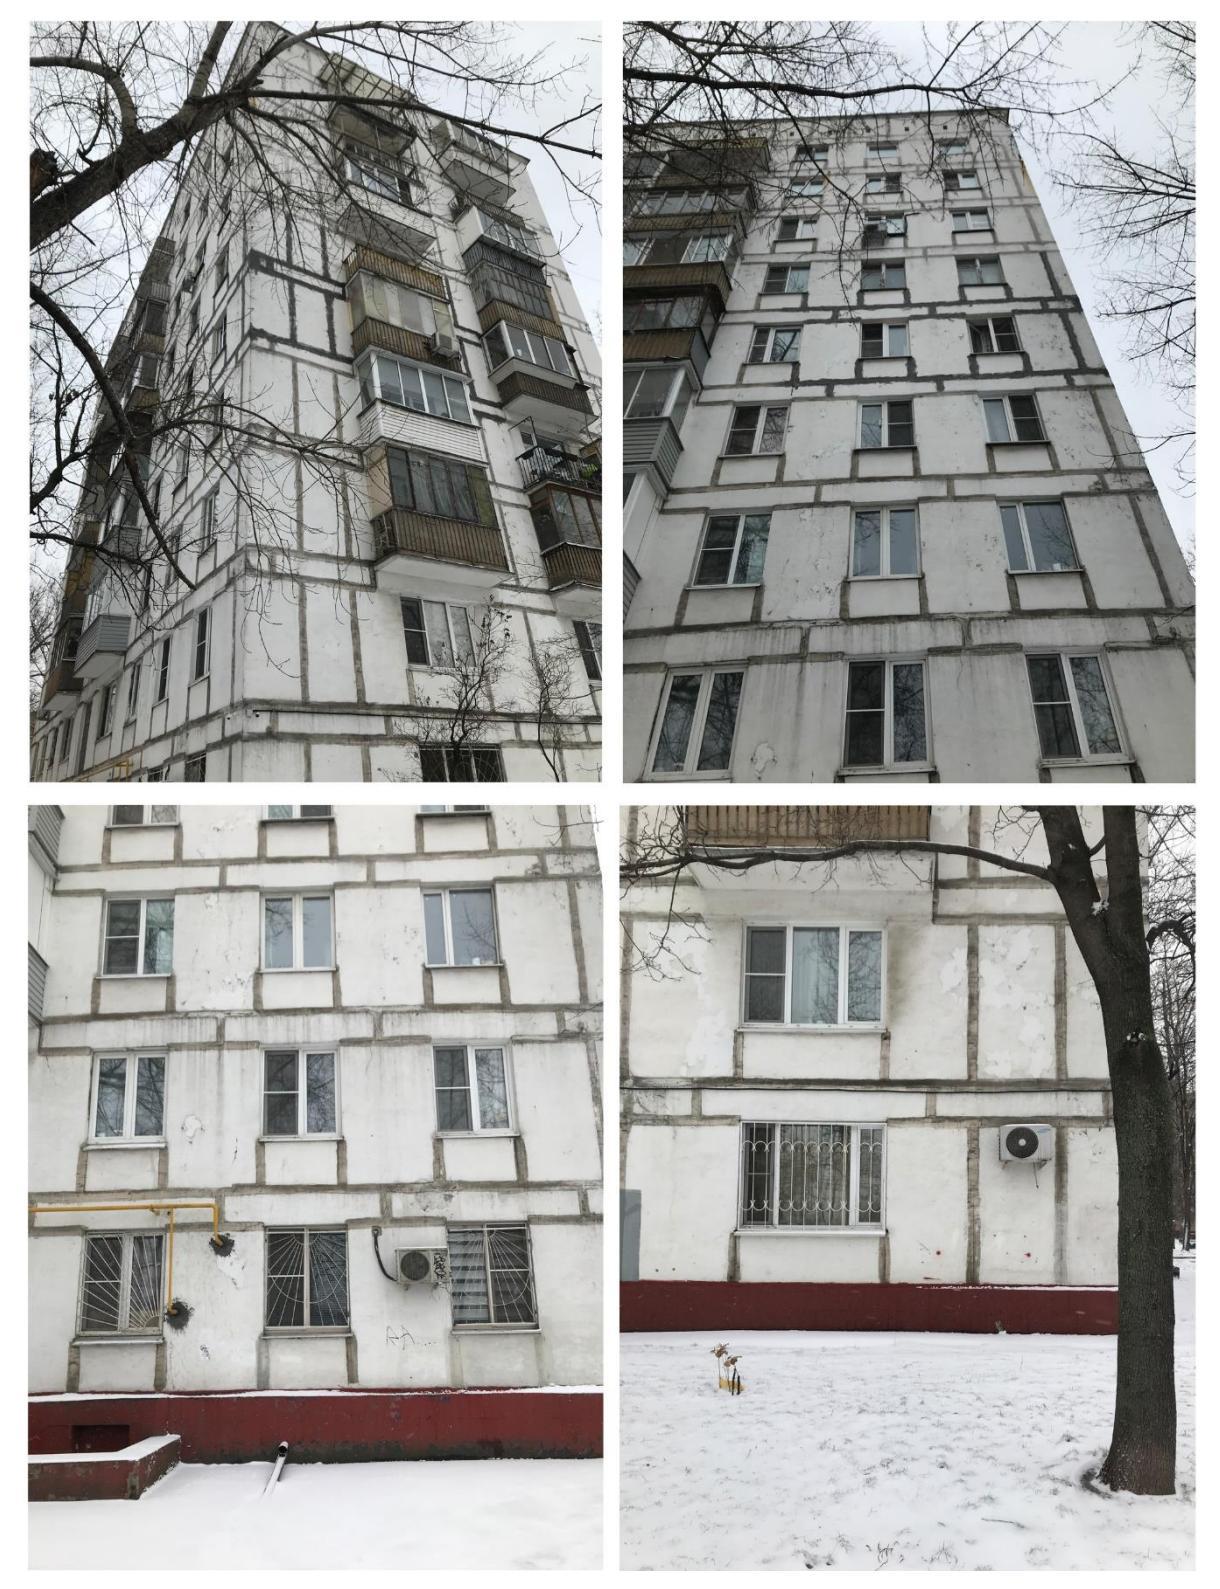
Figure A9 Building #9 The same symptoms as Building #1. Condition: Average

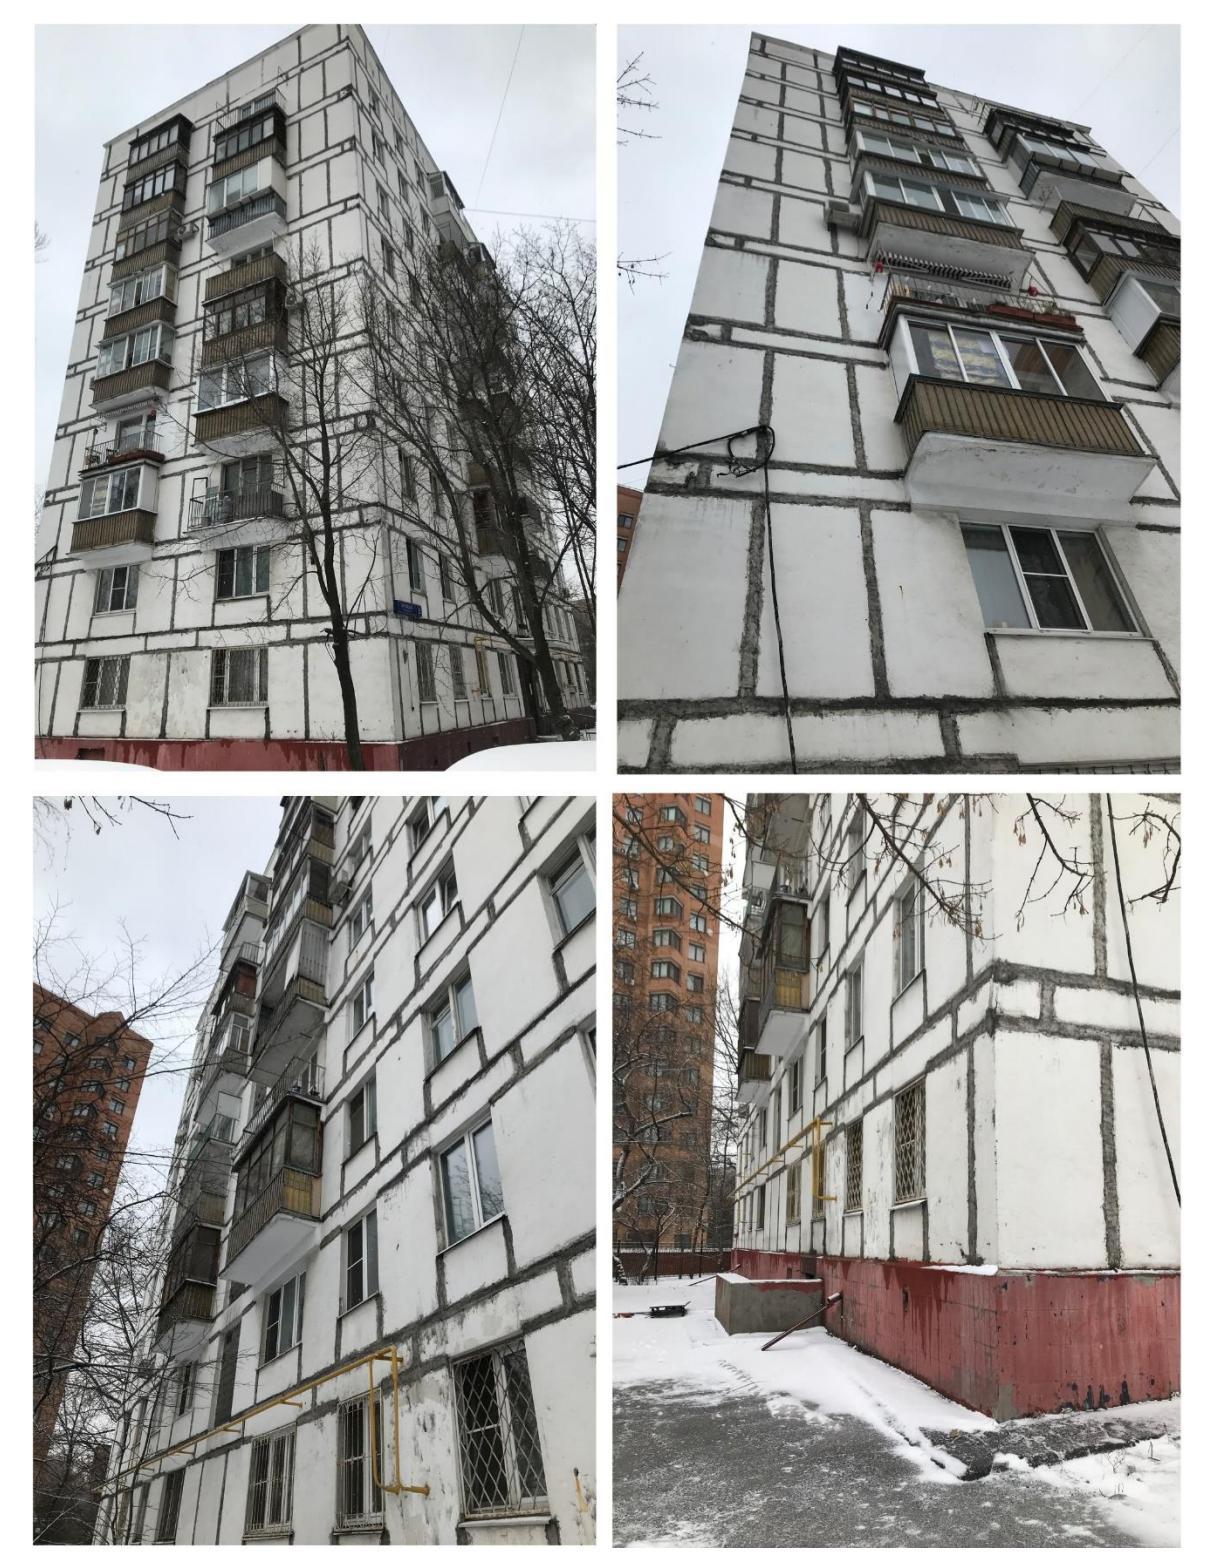
Figure A10 Building #10 The same symptoms as Building #1. Condition: Average
